Fire Resistance Testing of Metal Utility Poles

Investigative testing conducted following the test methodology similar to that of proposed ASTM standard, Standard test method for fire resistance of wood utility poles

**Valmont Utility
28800 Ida St
Valley, NE 68064**

WFCi Report #18050ar1

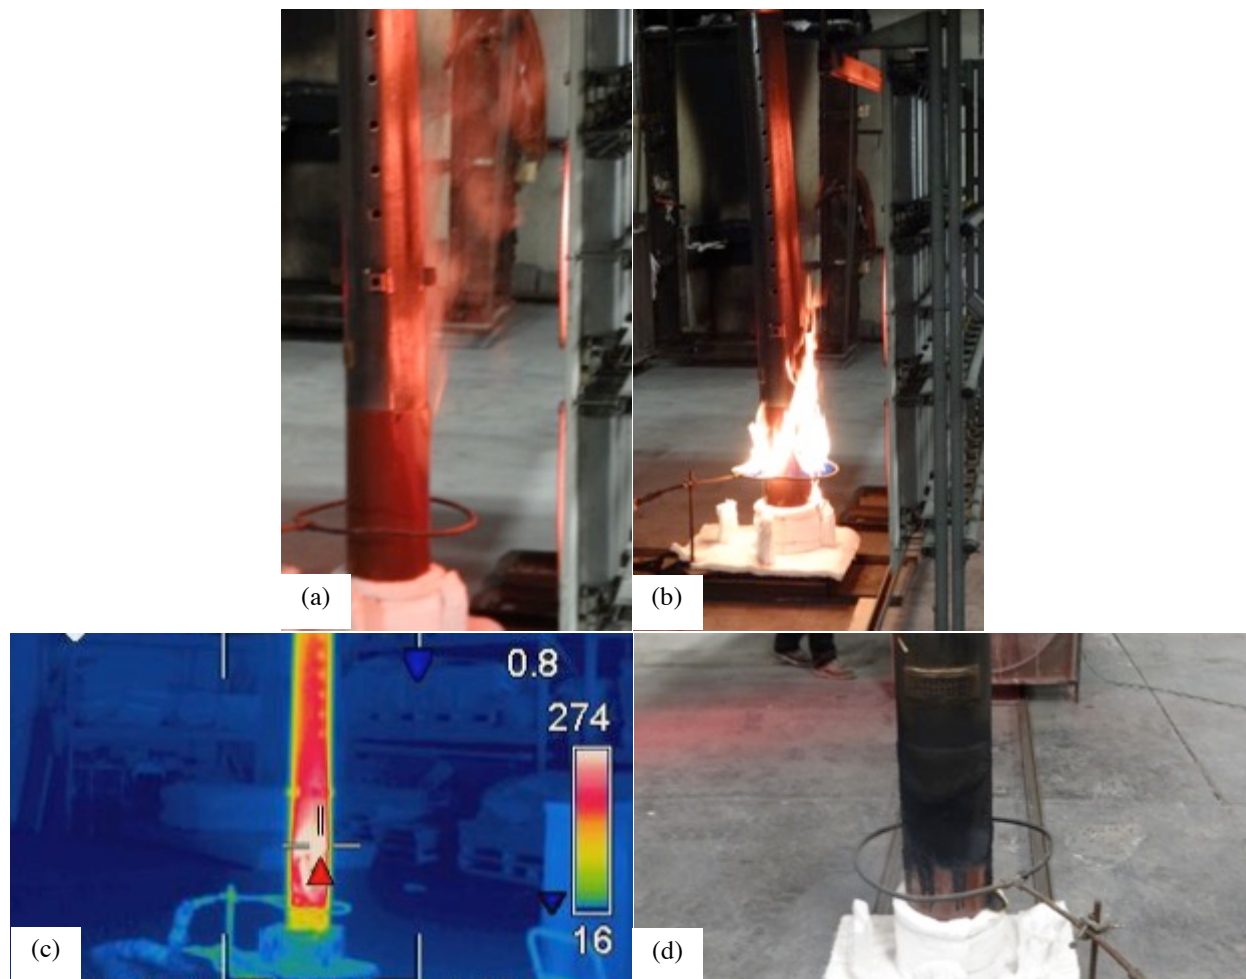
Figure 3. Test 1 showing (a) smoking, (b) ring burner, (c) IR in wind, and (d) after test.

No significant damage was observed of the metal pole. Some of the coating on the lower portion had deteriorated and bulged. The pole was returned to the client.

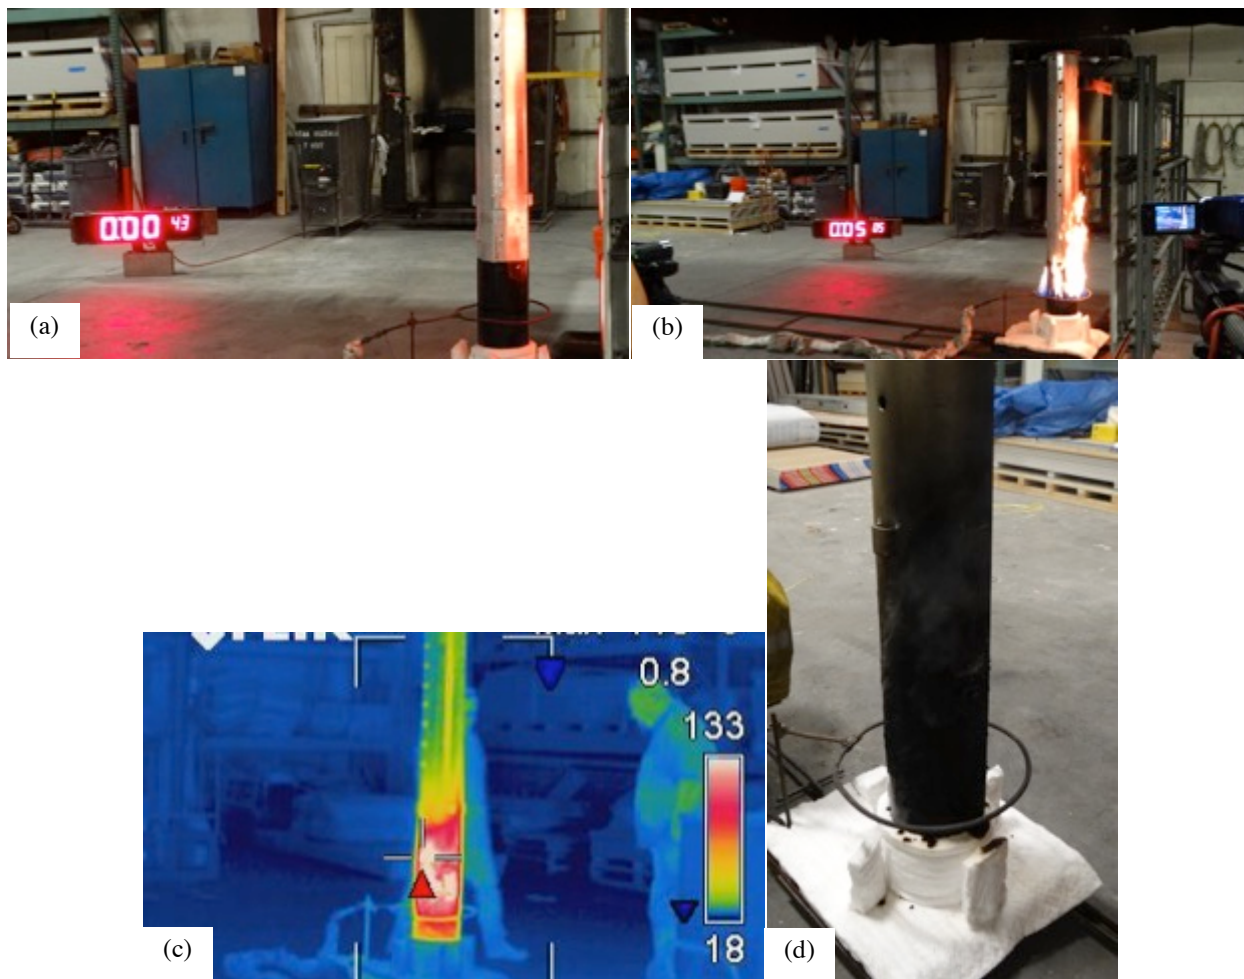
Figure 4. Test 2 showing (a) darkening, (b) ring burner, (c) IR in wind, and (d) after test.

No significant damage was observed of the metal pole. Some of the coating on the lower portion had deteriorated and bulged. The pole was returned to the client.

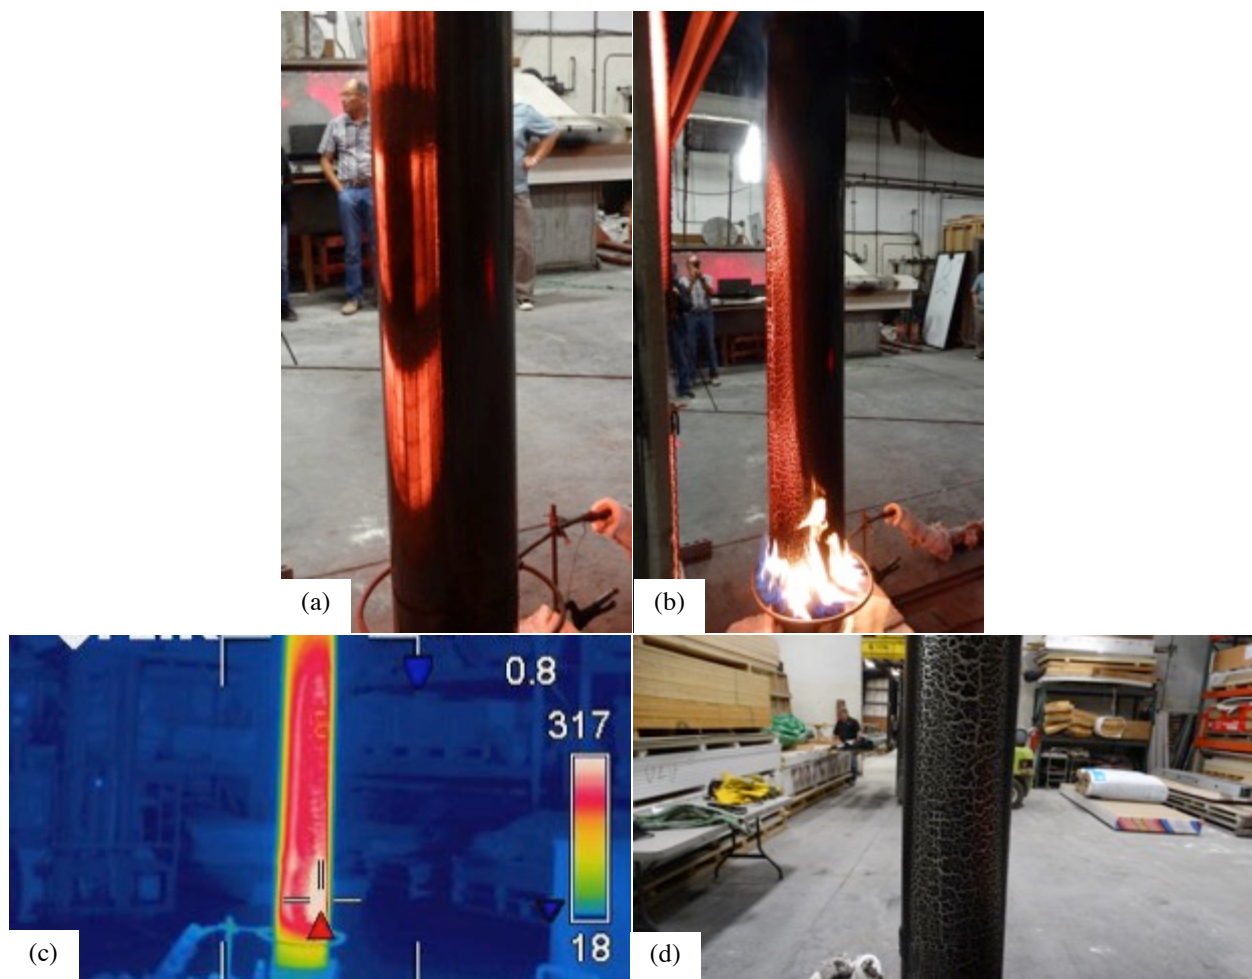
Figure 5. Test 3 showing (a) smoking, (b) ring burner, (c) IR in wind, and (d) after test.

No significant damage was observed of the metal pole. Some of the coating on the lower portion had deteriorated and bulged. The pole was returned to the client.
